## Testing of Joramark BOX300 according to ETAG 022 Annex F

Request by: Joramark Oy

**Task** **Testing of Joramark BOX300 according to ETAG 022 Annex F**

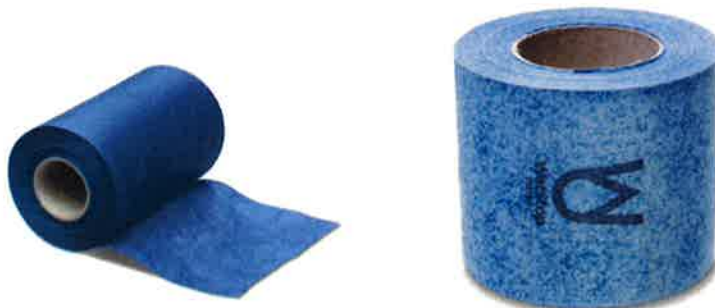
*Picture 1. The waterproofing reinforcement tapes used in the tests.*

**Performance of the task** Four gypsum boards size of 550x600 mm were primed with Casco Primer. The BOX300-hatches were attached in the holes in the centre of the test boards. The edges of the BOX300 hatches were cleaned, grinded and sealed with Casco waterproofing reinforcement tapes (picture 1). Two layers of Casco waterproofing membrane were applied.

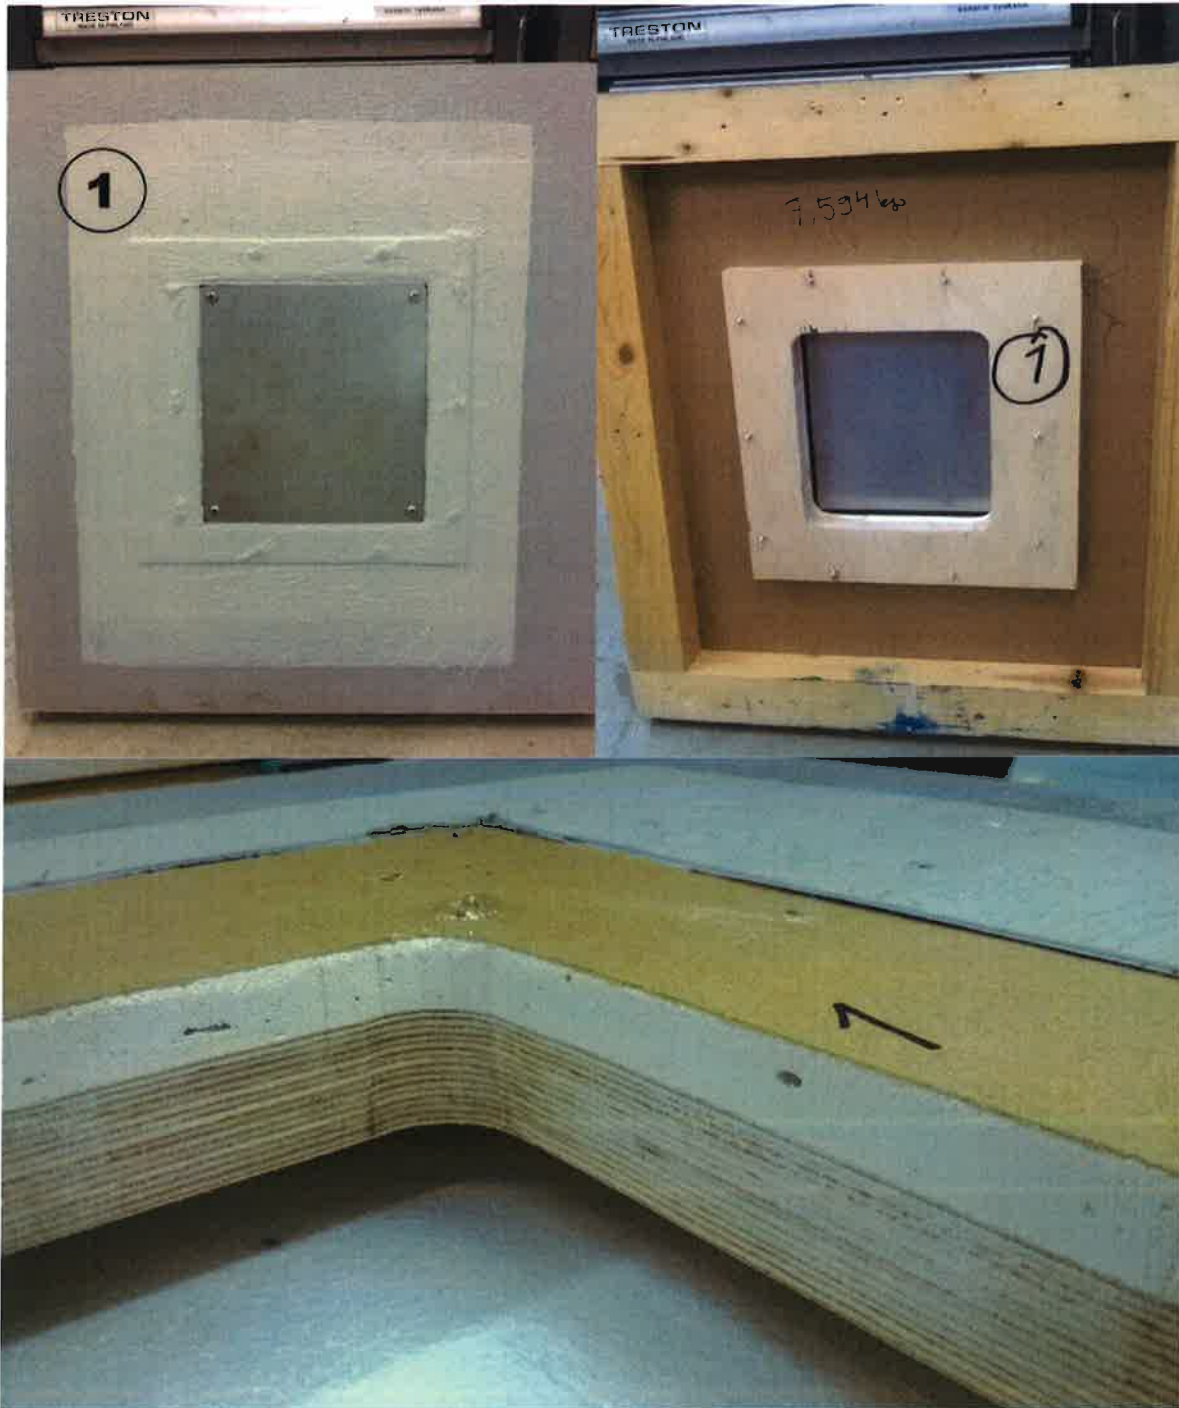
*Picture 1. Test specimen no. 1 after testing.*

After the test, the membranes and the reinforcement tapes were opened. The test specimens were examined visually for leakage using methylene blue -powder mixture. The moisture contents of the gypsum boards were measured after the test by weighing.

Product / Structure	Wet consumption	Result
BOX300 + Casco Waterproofing tape 3647	<u>Specimen 1</u> Primer <b>88 g/m<sup>2</sup></b> Waterproofing <b>1675 g/m<sup>2</sup></b>	ETAG 022 Annex F, <b>Watertight</b>
	<u>Specimen 2</u> Primer <b>79 g/m<sup>2</sup></b> Waterproofing <b>1717 g/m<sup>2</sup></b>	ETAG 022 Annex F, <b>Watertight</b>
BOX300 + Casco Wetstop KL-tape 3798	<u>Specimen 3</u> Primer <b>77 g/m<sup>2</sup></b> Waterproofing <b>1838 g/m<sup>2</sup></b>	ETAG 022 Annex F, <b>Watertight</b>
	<u>Specimen 4</u> Primer <b>75 g/m<sup>2</sup></b> Waterproofing <b>1879 g/m<sup>2</sup></b>	ETAG 022 Annex F, <b>Watertight</b>

Specimen no.	Under the edge of the reinforcement tape	Under the waterproofing membrane
1	0.3 %	0.3 %
2	0.3 %	0.3 %
3	0.3 %	0.3 %
4	0.3 %	0.3 %

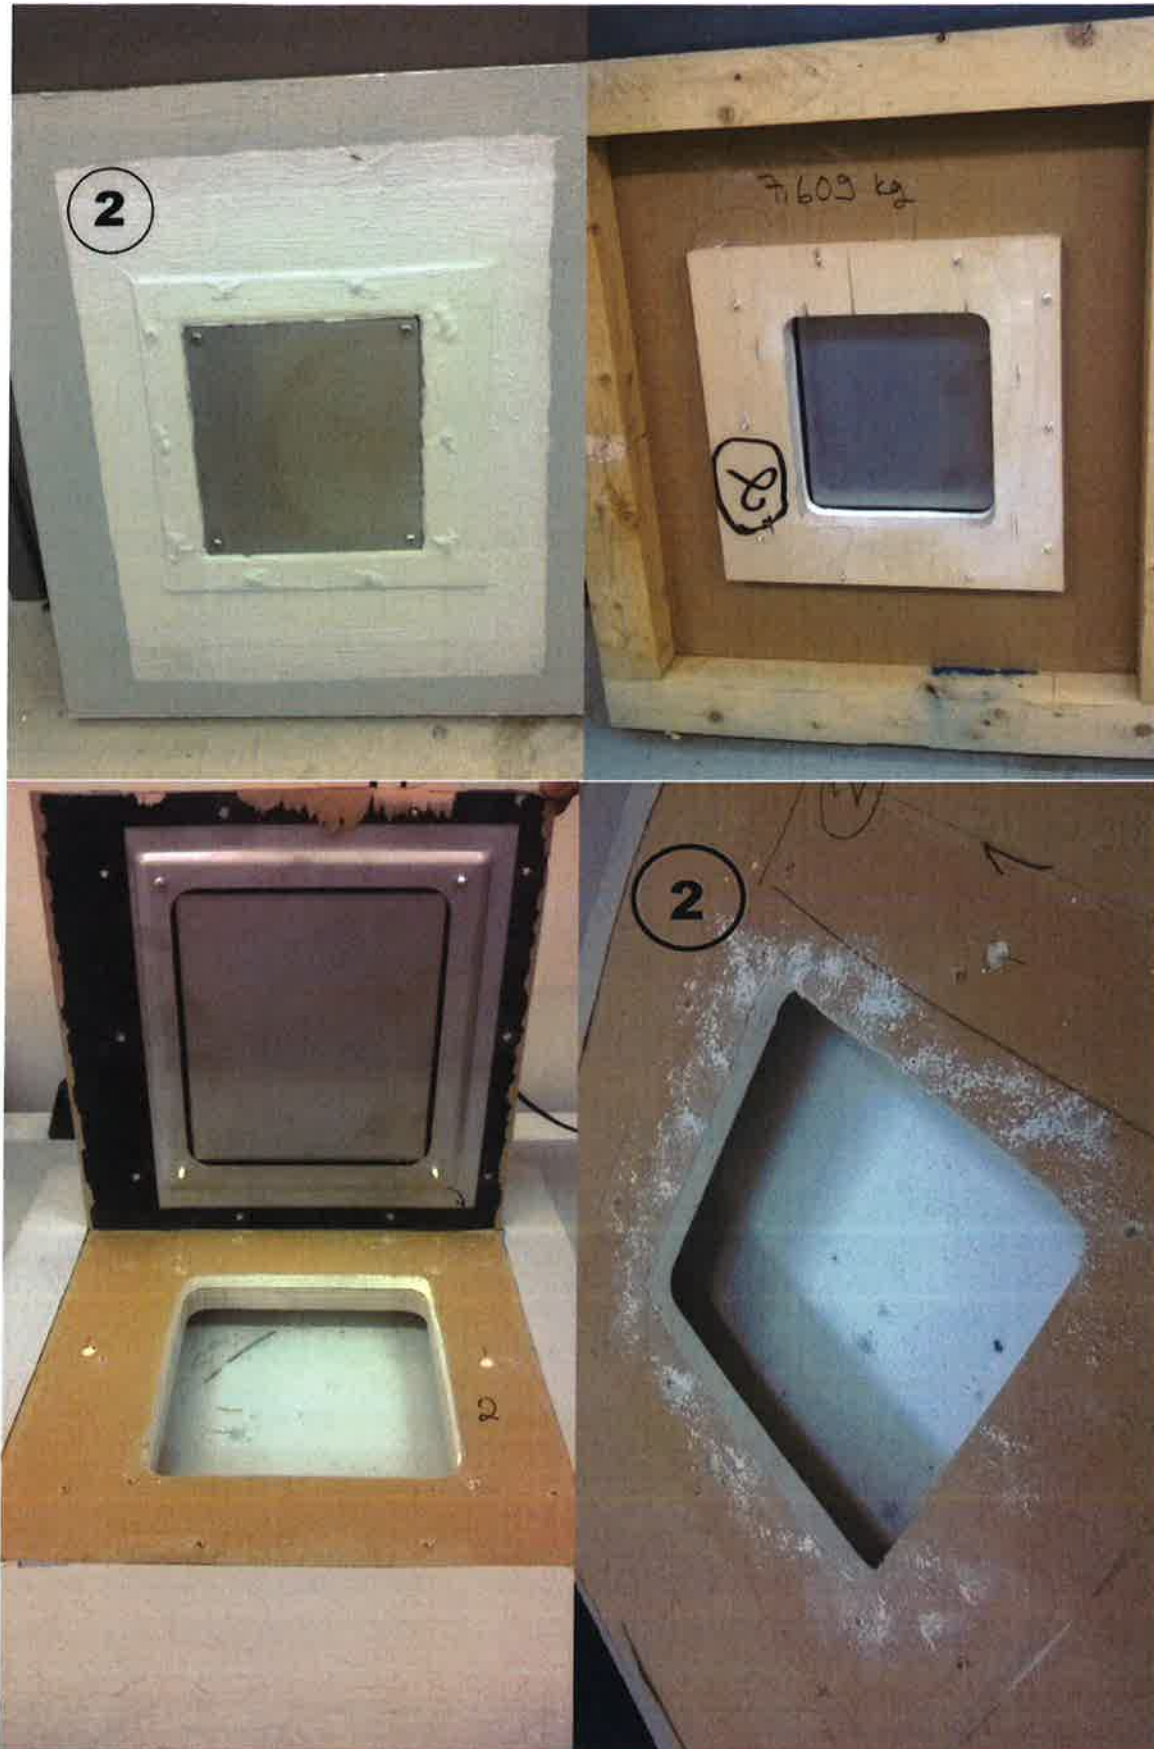
Picture 2. Test specimen no. 2 after testing.

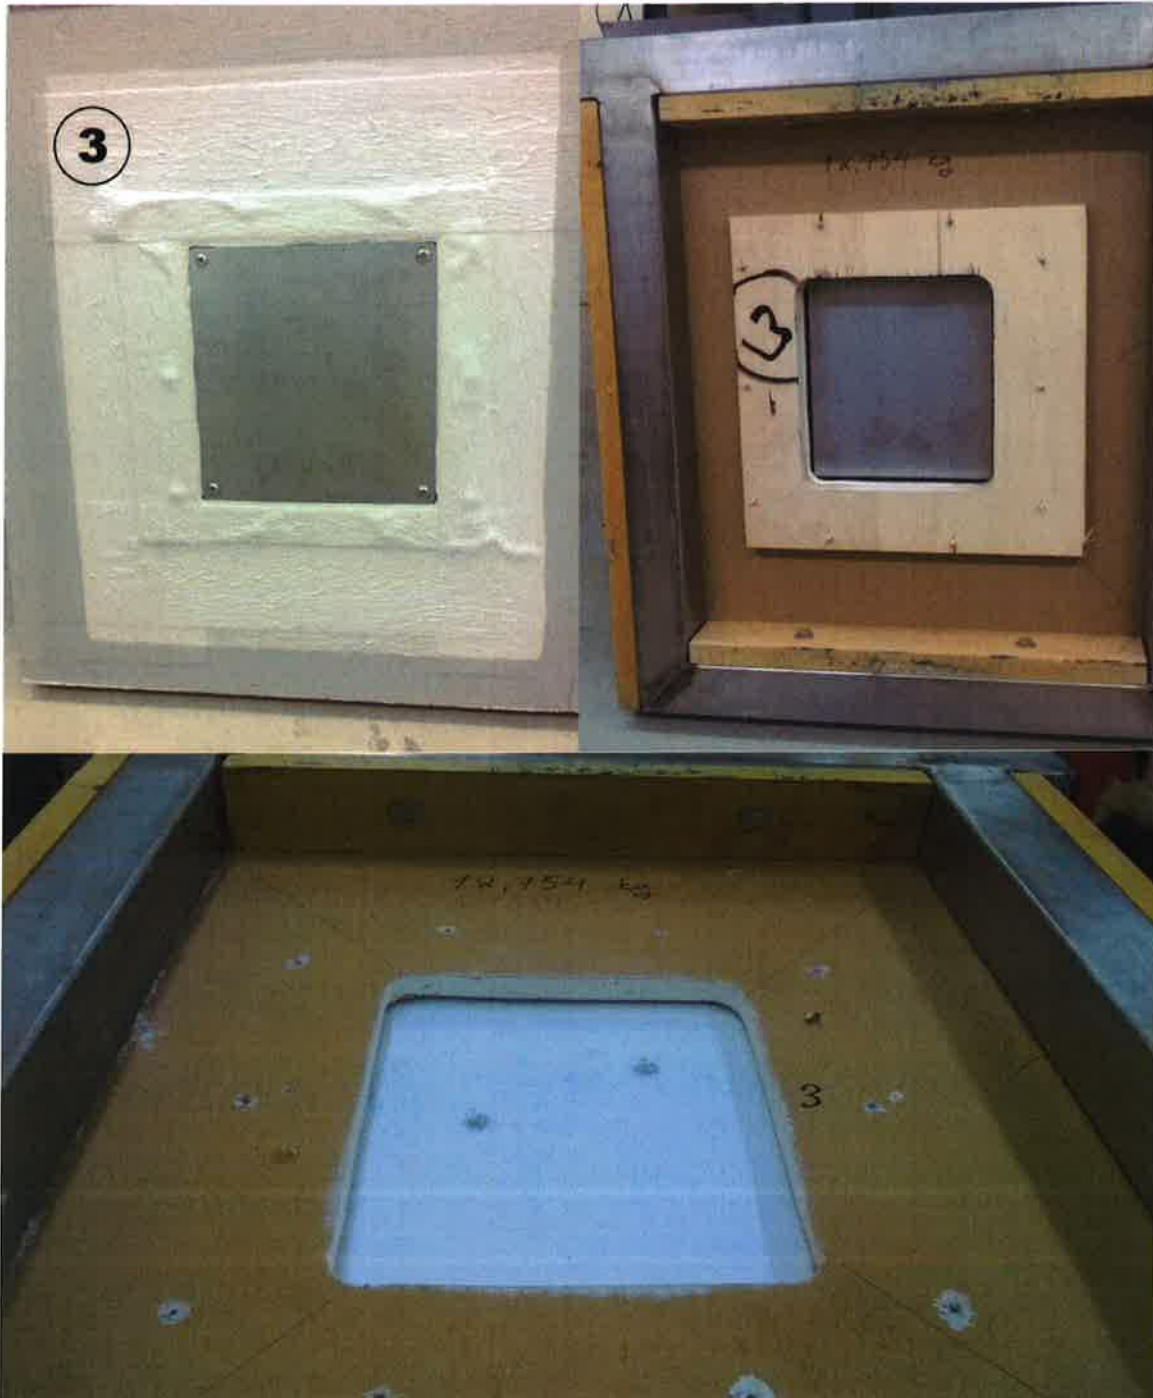
*Picture 3. Test specimen no. 3 after testing.*

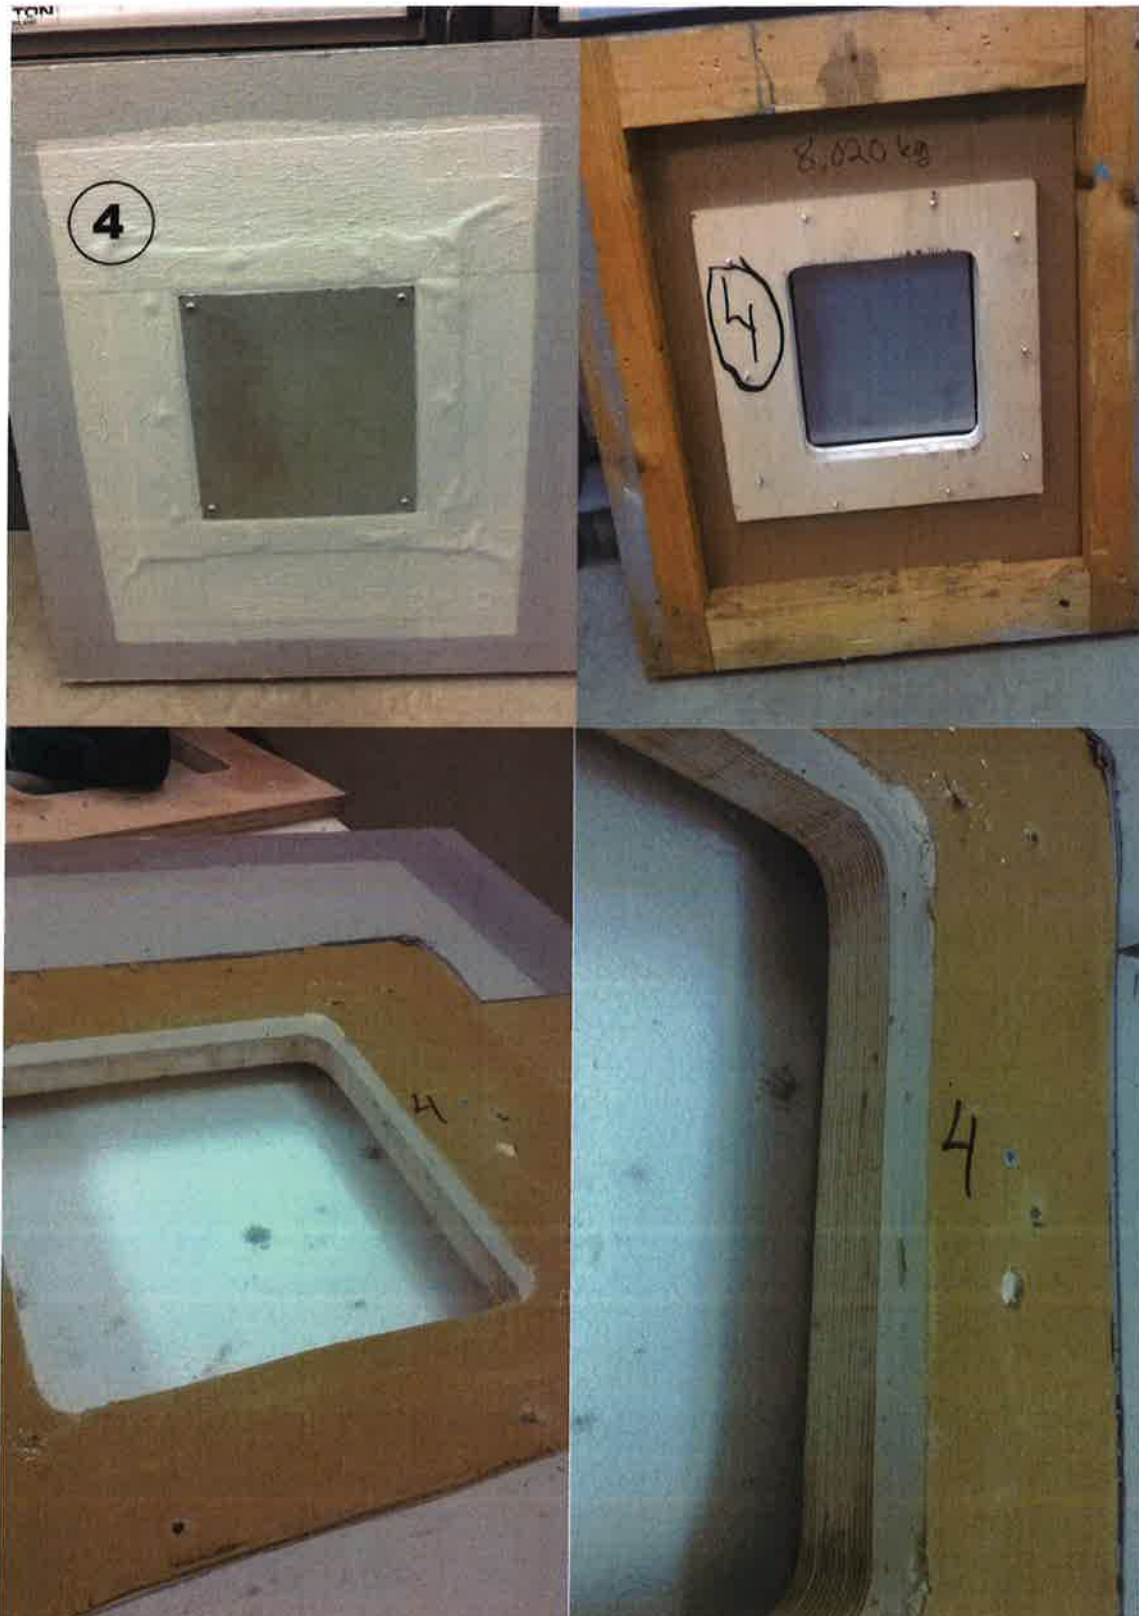
Picture 4. Test specimen no. 4 after testing.
