## Testing of Joramark BOX300 according to ETAG 022 Annex F

**Assignment** Testing of Joramark BOX300 according to ETAG 022 Annex F

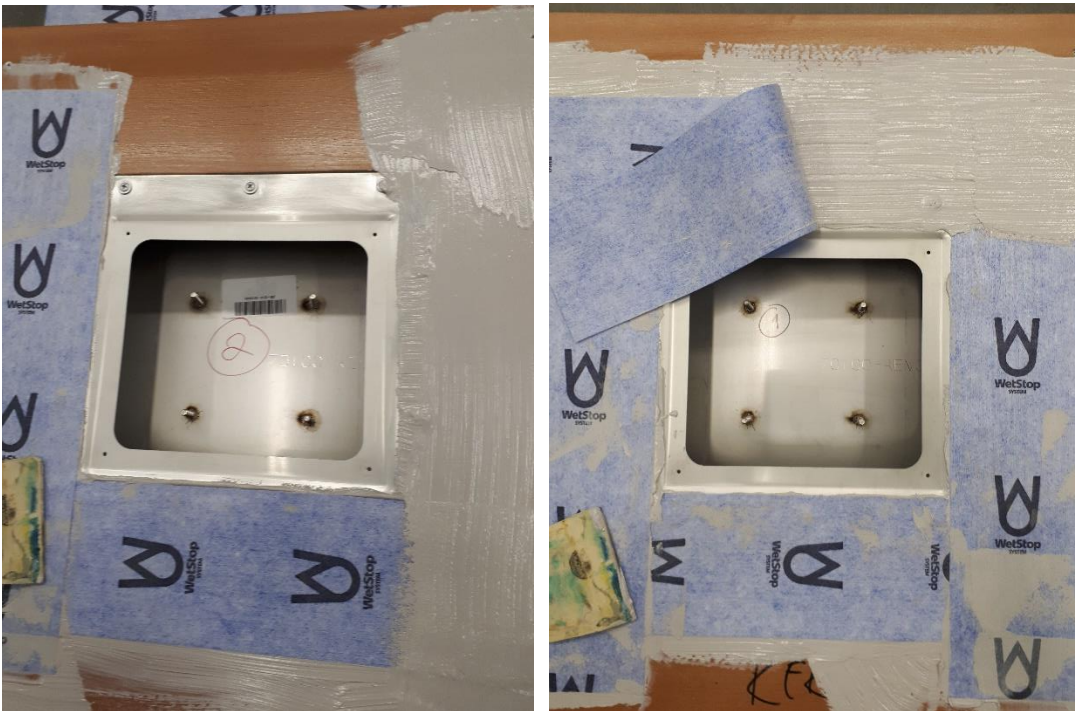
Picture 1-2. Preparation of test specimens WetStop KL-tape

Four gypsum boards size of 540x600 mm were primed with Casco Primer. The BOX300-hatches were attached in the holes in the centre of the test boards. The edges of the BOX300 hatches were cleaned, grinded and sealed with Casco waterproofing reinforcement tapes. Two layers of Casco waterproofing membrane were applied.

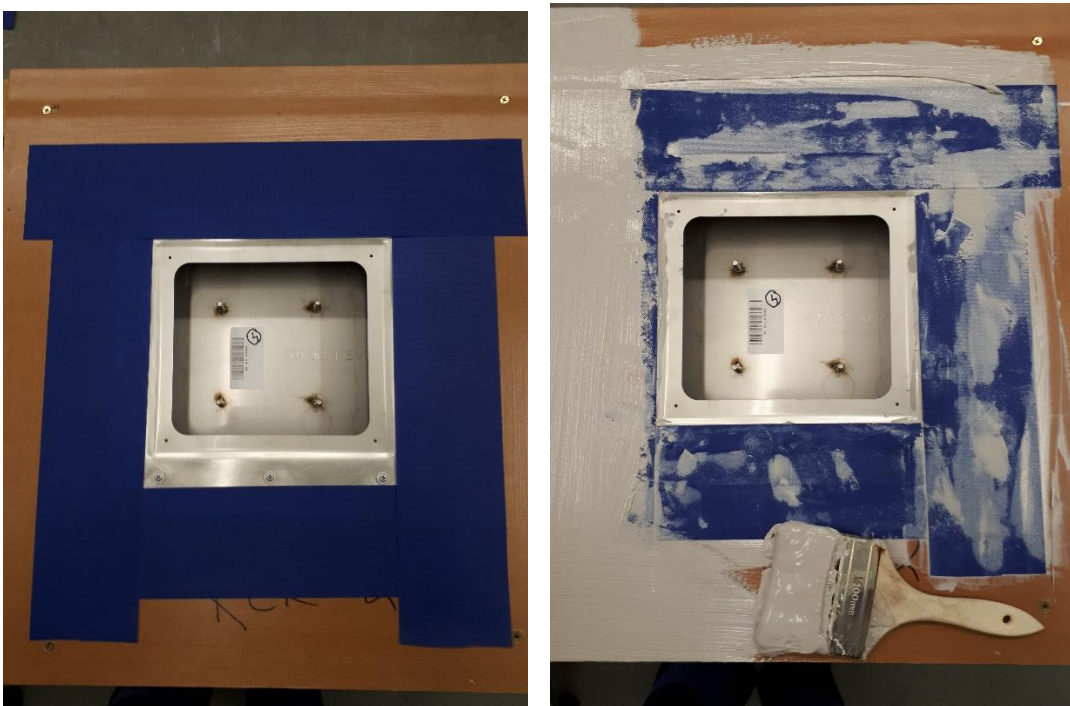
Picture 3-4. Preparation of test specimens Casco Waterproofing tape
