Testing of water tightness

2 pieces of Joramark Box300 including front plates, service plates and countersunk M4 screws.

Watertight covering kit based on flexible sheet designated LIP System 27.

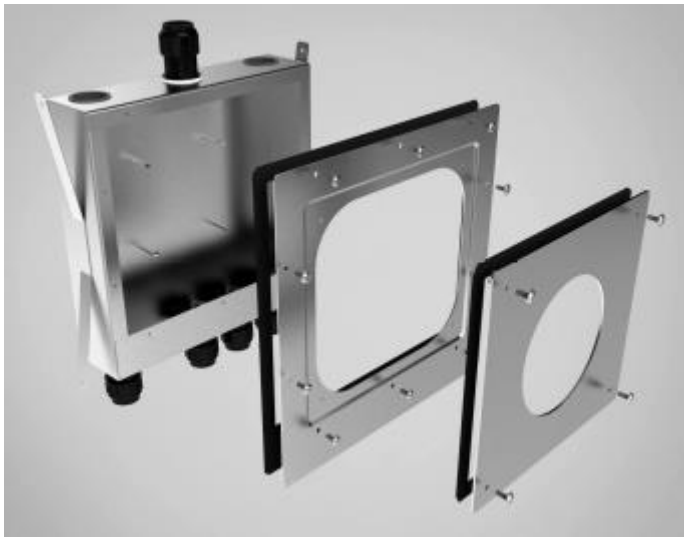
Image 1 – Joramark Box300 including front plate and service plate. The service plate used in this test did not have any hole.

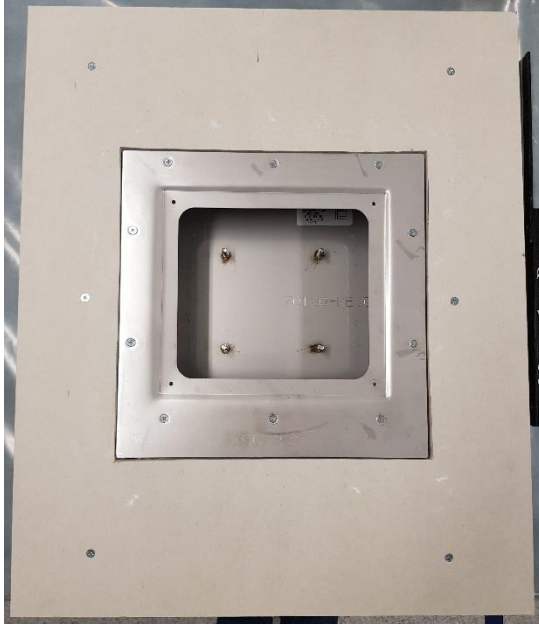
The box 300 was mounted between two wall studs. The studs were covered by a 13 mm plasterboard (500 x 600 mm). The hole in the plasterboard was 304 x 304 mm making a gap of 2 mm around Box 300. The box was mounted so that the front plate of Box300 was flush with the surface of the plasterboard.

Image 2 – Mounting of Joramark Box300 in a plasterboard

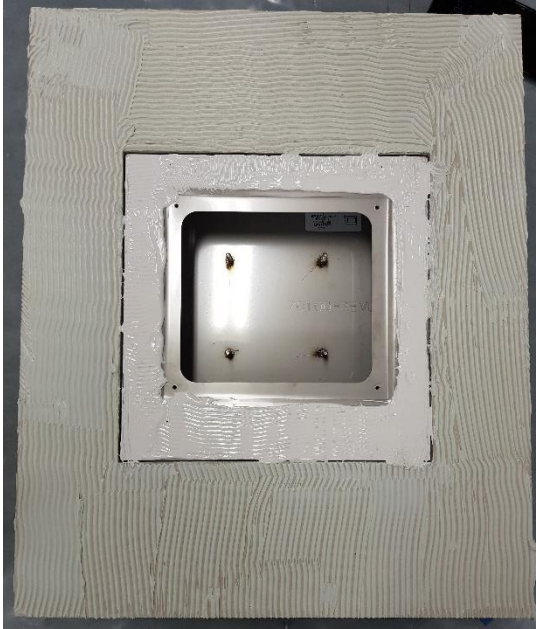
The water tight foil **LIP Folie G3** was then glued to the stainless steel with **LIP skarvlim MSP** and to the plasterboard with **LIP 2K folielim**.

Image 3 - LIP skarvlim MSP on the front plate and LIP 2K folielim on the plasterboard

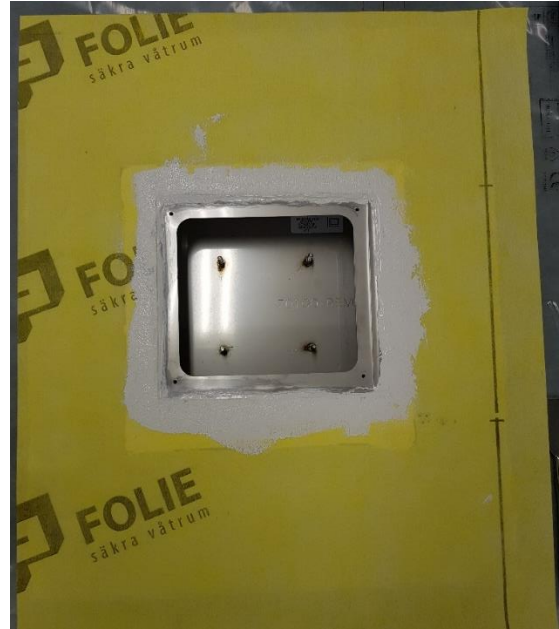
Image 4 - LIP Foile G3 applied and the edges sealed with LIP skarvlim MSP

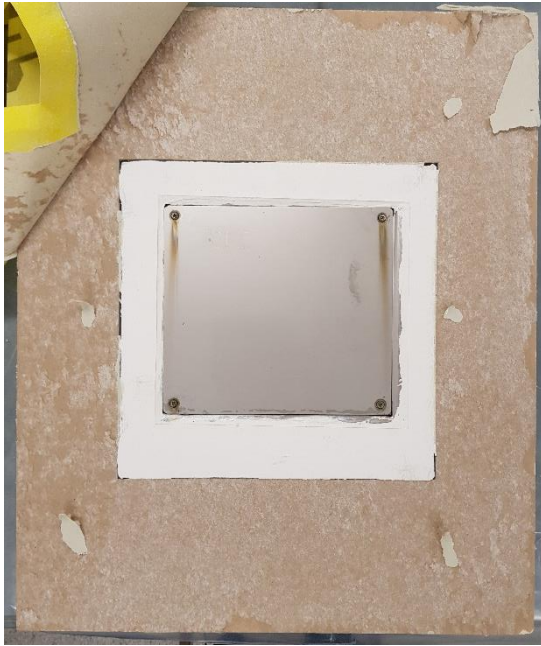
The tape was removed from the back and the gap was inspected for colour change of the moisture indicating powder. The foil was removed to uncover the plasterboard and the plasterboard inspected for any signs of leakage.

No indication of leakage could be detected on any of the panels.

Image 5 – LIP Foil removed for inspection of leakage
