Testing of water tightness

2 pieces of **Joramark Box300** including front plates, service plates and countersunk M4 screws.

The test is performed according to EAD 030352-00-0503 Annex F *Water tightness around penetrations and other details in wet room walls with flexible substrate*.

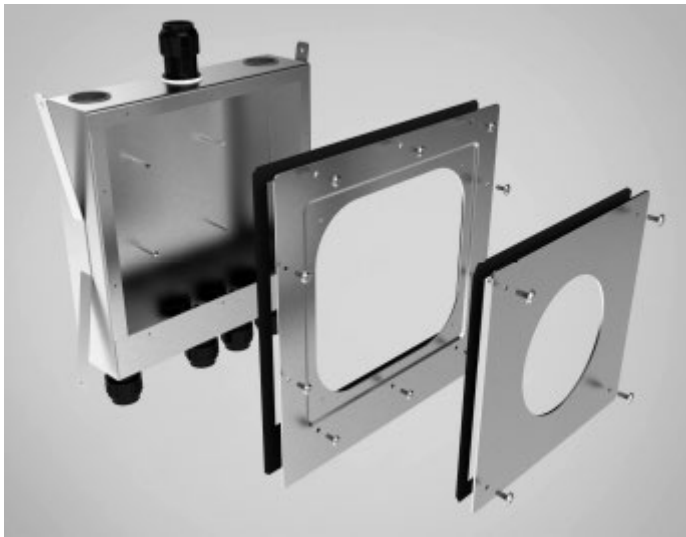
Image 1 – Joramark Box300 including front plate and service plate. The service plate used in this test did not have any hole.

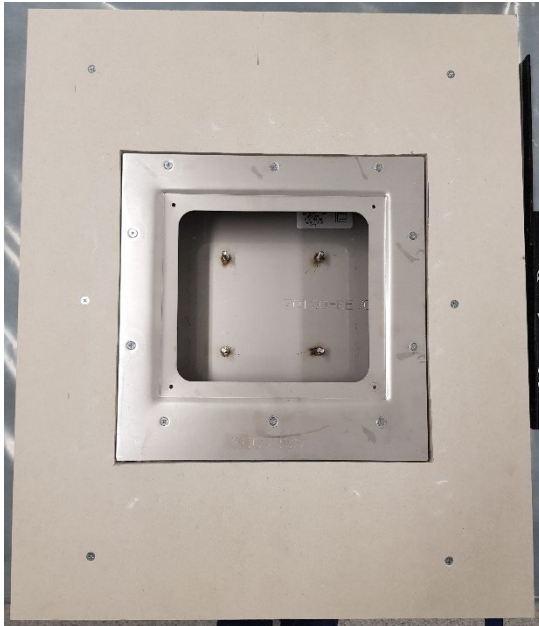
The box 300 was mounted between two wall studs. The studs were covered by a 13 mm plasterboard (500 x 600 mm). The hole in the plasterboard was 304 x 304 mm making a gap of 2 mm around Box 300. The box was mounted so that the front plate of Box300 was flush with the surface of the plasterboard.

Image 2 - Mounting of Joramark Box300 in a plasterboard

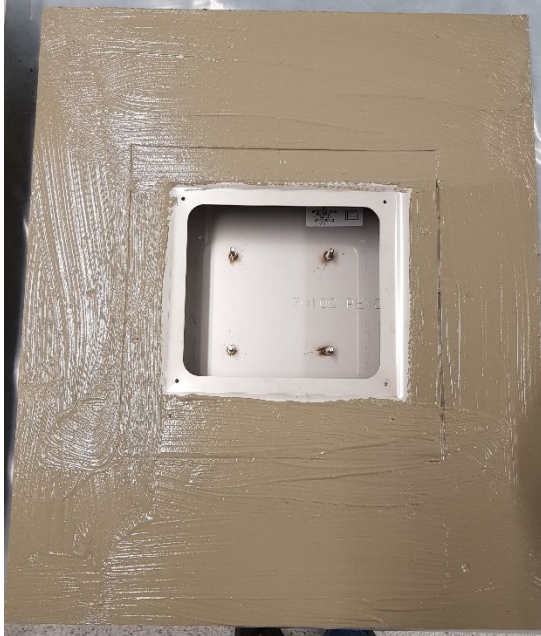
The stainless steel of the front plate was cleaned with T-Röd (denaturated alcohol).

The water tight foil **Webertec Folie** was then glued to the stainless steel with and to the plasterboard with **Webertec folie- och skarvlim**.

Image 3 – Webertec folie- och skarvlim applied on the front plate and on the plasterboard

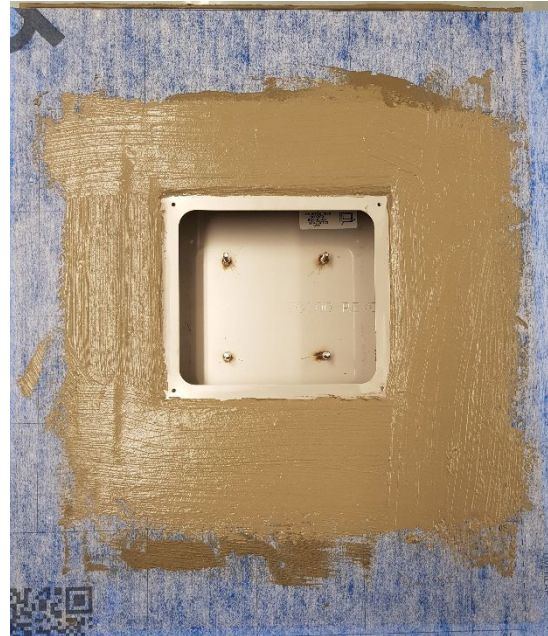
Image 4 – Webertec folie applied and the edges sealed with Webertec folie- och skarvlim

After the foil had been applied the edges were sealed with a layer of Webertec folie- och skarvlim. The panels were allowed to dry for approximately 40 minutes before a second layer of Webertec folie- och skarvlim was applied on the sealed edges.

Approximately 600 g/m² was used to glue the foil.

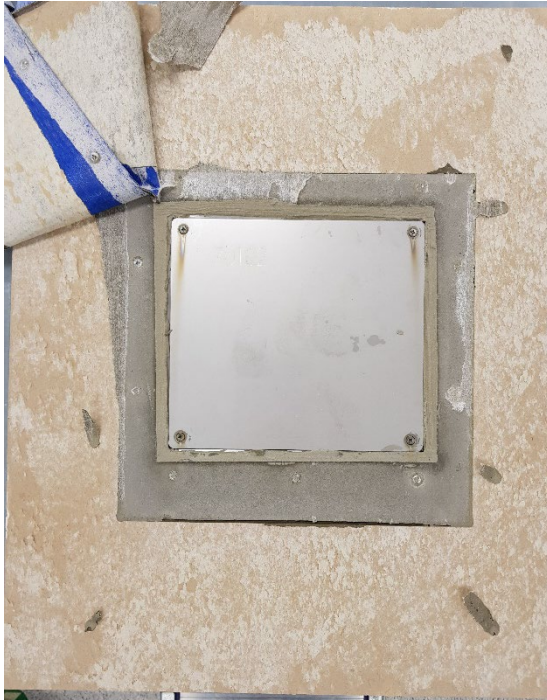
The tape was removed from the back and the gap was inspected for colour change of the moisture indicating powder. The foil was removed to uncover the plasterboard and the plasterboard was inspected for any signs of leakage.

No indication of leakage could be detected on any of the panels.

Image 5 – Webertec folie has been removed for inspection of leakage
